MODELS 2100 AND 2150 SELECTOR BUTTON SWATCH ASSEMBLY

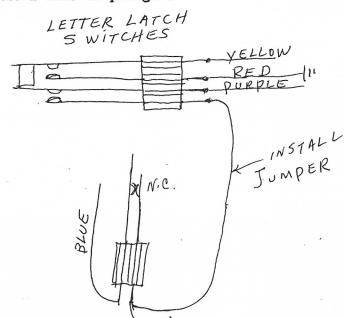
8/10 amp. fuse intermittently blowing in letter coil circuit or letter coil burns out if circuit is overfused.

Latch Solenoid, Part No. 60717, won't release selector battons and open the letter and number button latch switches due to intermittent bind of plunger in latch coil.

- 1. Remove selector button switch assembly.
- 2. Detach red wire connected to ground from both letter button latch switches located near coin counter on Model 2100. On Model 2150 from number button latch switches located on right hand side of selector button switch panel.
- 3. Connect red grounded wire to vacant lug on latch switch with yellow wire.
- 4. Connect new piece of wire to vacant lug on latch switch with violet wire.
- So Connect other end of new wire to series switch (located near latch sole noid) on lug with yellow wire #47(Other end of this yellow wire terminated on Pin 4, Plug 4 of selector button switch cable.)

This change automatically opens the 24 volt A. C. circuit to the letter coils after T. R. #1 is released. T.R. #1 CANNOT BE ENERGIZED UNTIL LATCH SOLENOID IS RELEASED TO CLOSE SERIES SWS.

Check latch solenoid for mechanical bind of plunger.
