# SERVICE SLANTS

ISSUED BY WURLITZER SERVICE DEPT., NORTH TONAWANDA, N. Y.

October 1, 1946

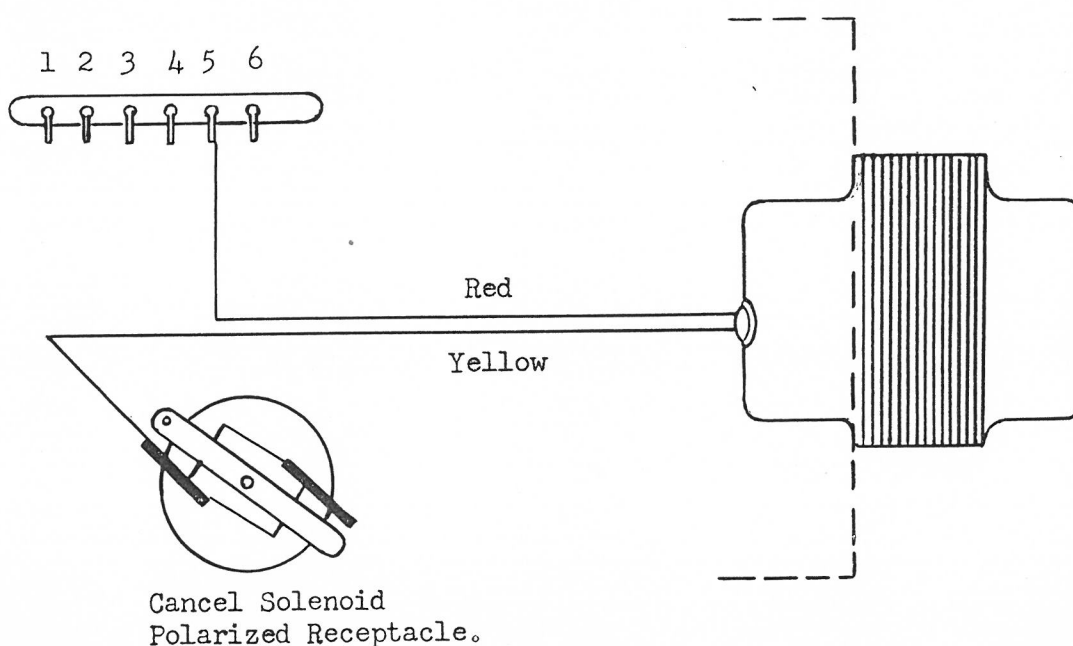
The incorrect wiring gives you trouble when you attempt to operate Model 3020 three wire system, wall boxes. Wall boxes on a line from terminal strip "B" of stepper will function properly and those on a line from terminal strip "A" of stepper will not operate. Switching the two wires corrects phasing in this circuit.

On all Model 1017's having a serial number between 1,918,001 and 1,918,299 it will be necessary to reverse the RED and YELLOW leads from the transformer in the Junction Box.

Correct position for connection of these secondary leads are as indicated below:
