SERVICE SLANTS

ISSUED BY WURLITZER SERVICE DEPT., NORTH TONAWANDA, N. Y.

TURNTABLE DRIVE CLUTCH ASSEMBLY

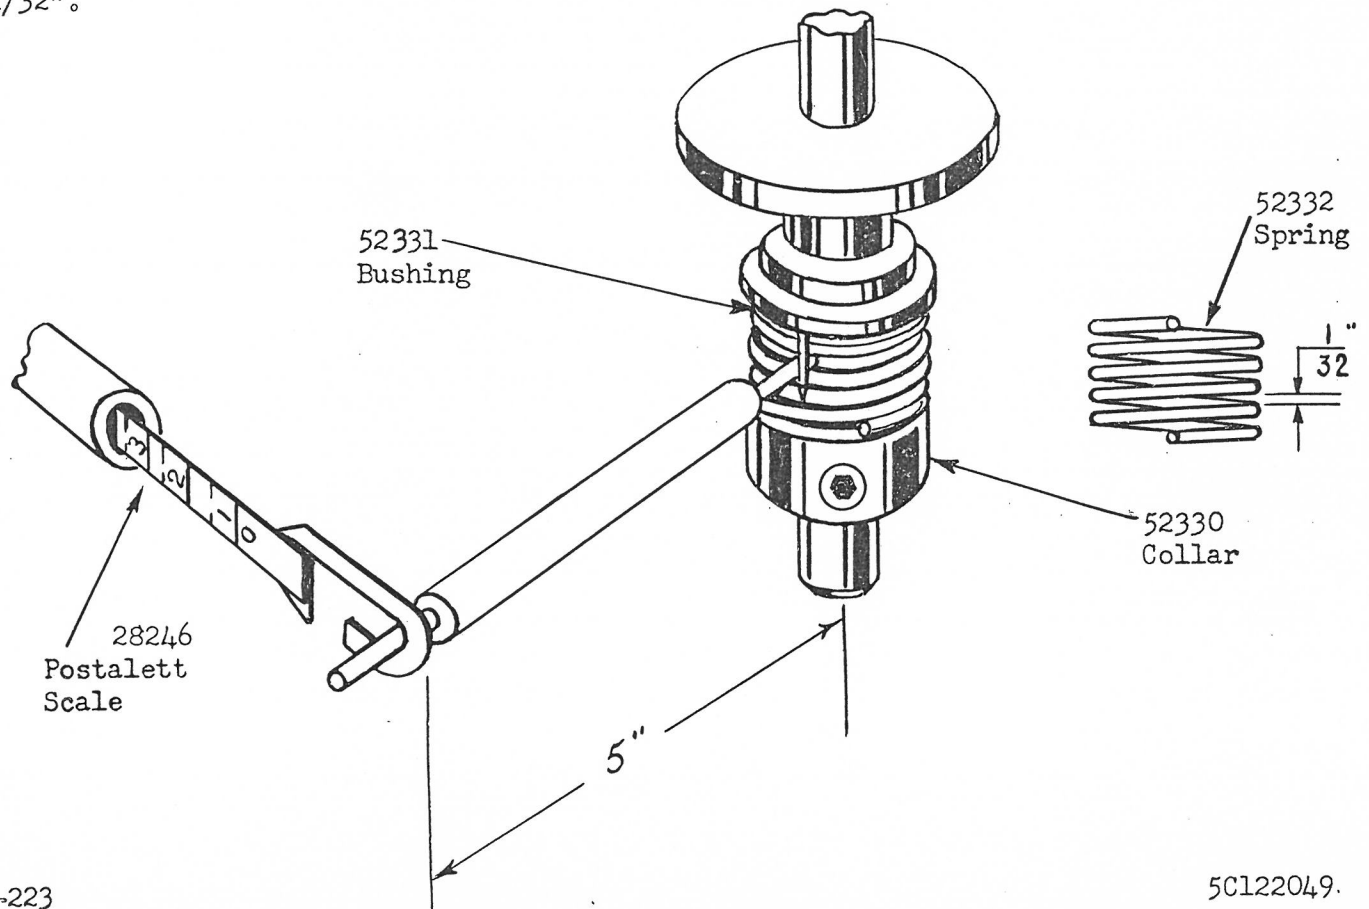
There may be some turntable drive clutch assemblies (Part No. 52355) which provide insufficient torque. Waver may result from assemblies that have torque of less than 10 inch ounces. In case waver does exist and the spring tension between bushing (52331) and turntable drive gear 52365 is correct, and coil spring 52332 provides 15 to 20 inch ounces of torque on drive clutch collar 52330, the trouble is undoubtedly from another cause.

Too tight a spring on the drive clutch collar is likely to bump and hunt, where as too loose a spring may slip due to friction. The clearances provided herein are good average figures for normal friction and the full range of needle drag.

With turntable in playing position, clutch height adjustment should be at a point where the spring will have clearance between its coils but not in excess of $\frac{1}{32}$ ".
