# SERVICE SLANTS

ISSUED BY WURLITZER SERVICE DEPT., NORTH TONAWANDA, N. Y.

SUBJECT: Model 1900 Ventilation

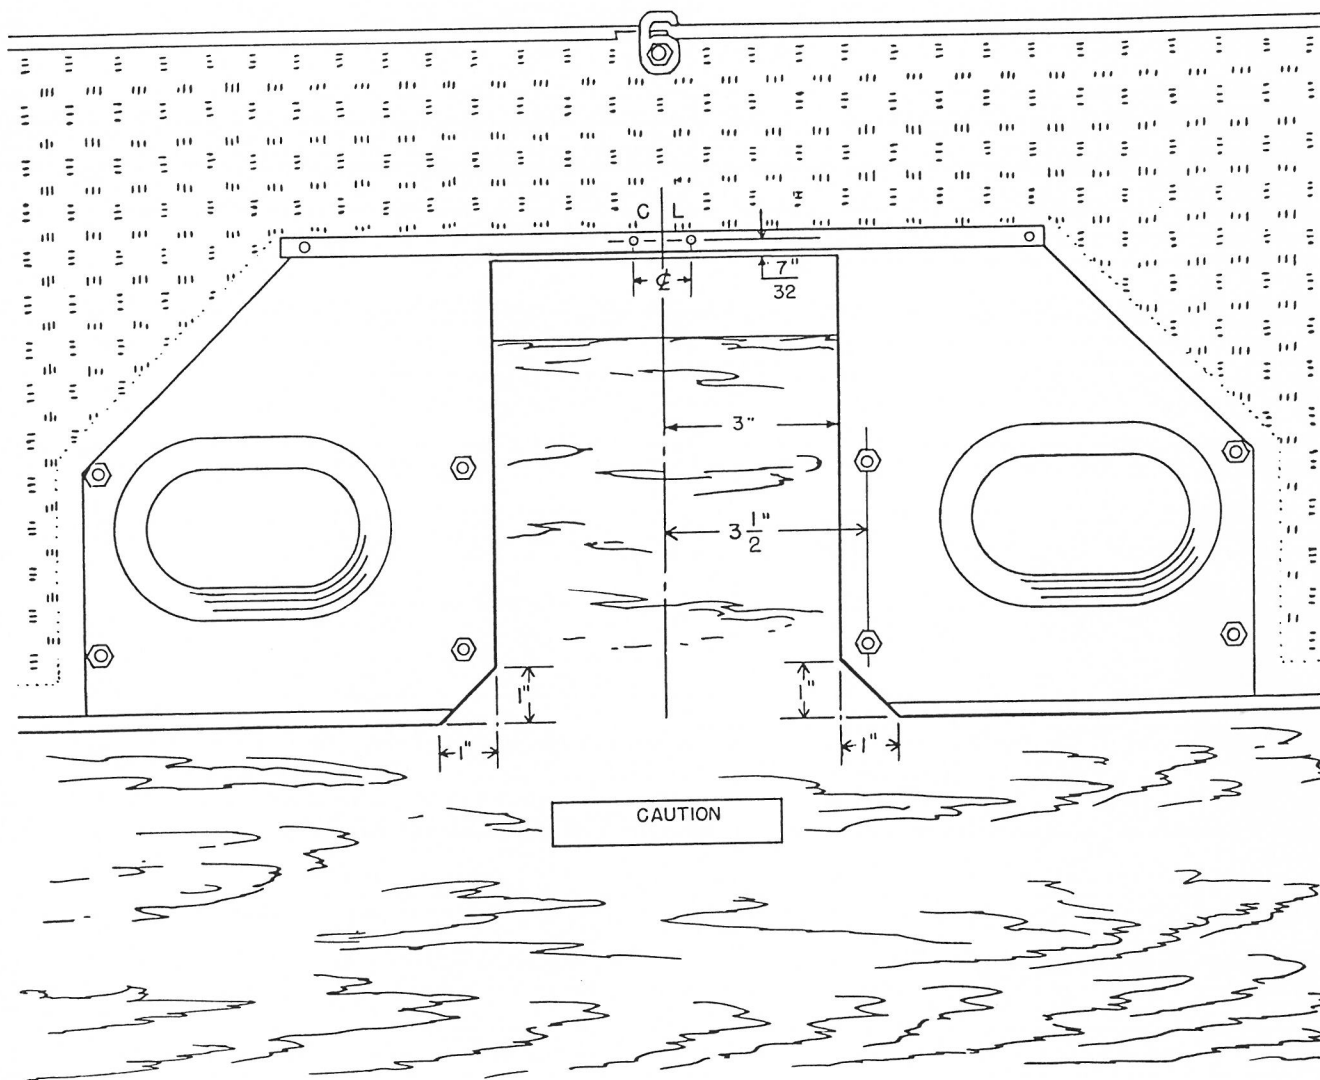
In some cases it may be found that early Model 1900's evidence insufficient ventilation. These phonographs will be found prior to Serial Number 252700.

To relieve this situation it is suggested that the front of the upper back be cut out in accordance with the sketch below.
