SEEBURG PHONOGRAPH
CONTROL CENTRES

GENERAL INFORMATION

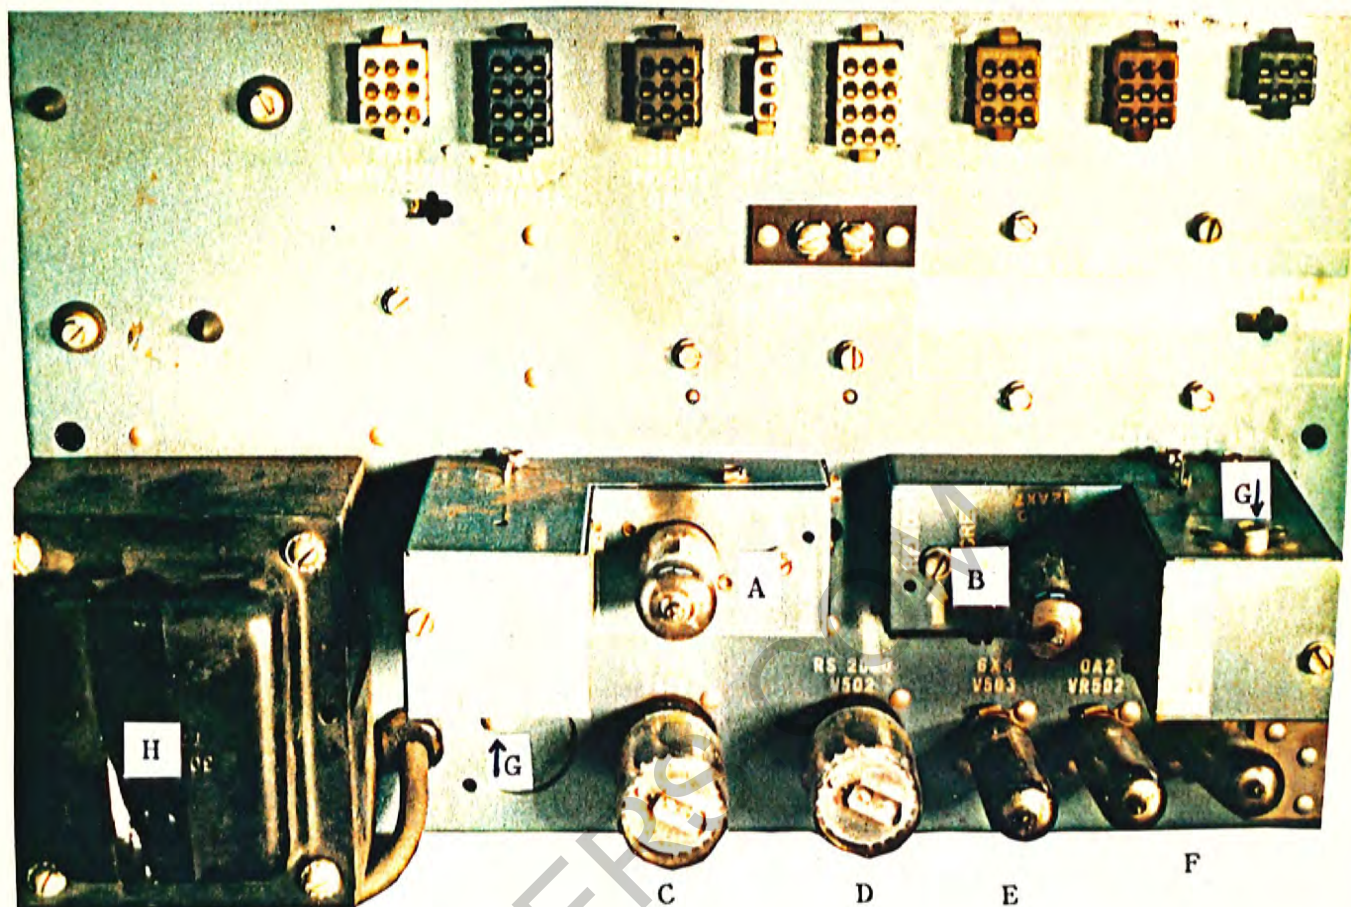
FIG 1 TCC1 CONTROL CENTRE

2. OBSERVE THE OA2 VOLTAGE REGULATOR TUBES. THEY SHOULD SHOW A PURPLE GLOW INSIDE. THIS PURPLE GLOW WILL VARY ("FLICKER") IN INTENSITY AS THE MECHANISM SCANS FROM LEFT TO RIGHT AND STAY STEADY AS THE MECHANISM SCANS FROM RIGHT TO LEFT. THE FLICKERING IS CAUSED BY THE CLOSING AND OPENING OF THE "DETENT" (R.O.) SWITCH AS IT READS OUT BOTH SIDES OF EACH RECORD (ON THE LEFT TO RIGHT SCAN). THE READ-OUT (R.O.) IS DISABLED ON THE RIGHT TO LEFT SCAN. THEREFORE, THE GLOW INSIDE THE OA2 TUBES REMAINS STEADY. IF NO GLOW CAN BE DETECTED INSIDE THE OA2'S AT ALL, CHECK THE 6X4 HIGH VOLTAGE RECTIFIER TUBE. YOU ARE LOOKING FOR THE RED GLOWING FILAMENT AT THE CENTRE OF THIS TUBE. IT IS ADVANTAGEOUS TO REPLACE THIS TUBE WHEN THE OA2'S ARE NOT SHOWING THE PURPLE GLOW, WHETHER THE GX4 FILAMENT IS LIT OR NOT.

3. CHECK THE 2050 "TRIP" TUBES. THERE IS ONE FOR THE "LEFT" AND ONE FOR A "RIGHT" SIDE SELECTION. THESE TUBES SHOULD ALSO HAVE A GLOWING FILAMENT LIKE THE 6X4 TUBE. IN ADDITION, IN ORDER TO TEST THE PROPER FUNCTION OF THESE TUBES, YOU MUST MAKE A "DOUBLE-SIDED" SELECTION; THAT IS, YOU SHOULD SELECT SAY "A8 AND B8",

IT MAY BE POSSIBLE THAT ONLY ONE SIDE (SAY THE RIGHT SIDE) OF A RECORD IS PLAYED, EVEN THOUGH BOTH SIDES HAVE BEEN SELECTED. IT WILL HELP HERE TO INTERCHANGE THE TWO 2050 TUBES AND THEN TO TRY AGAIN. IF THE SAME SELECTION (AS ABOVE) IS PLAYED (SAY THE RIGHT SIDE ONLY), THE INTERCHANGE HAD NO EFFECT AND THE FAULT LIES ELSEWHERE. IN THIS CASE, OBSERVE THE TWO 12AX7 TUBES (CHECK FOR THE RED GLOW OF THEIR FILAMENTS). THESE ARE THE SENSING TUBES WHICH HANDLE THE SIGNAL GENERATED BY THE TORMAT UNIT WHEN A "SELECTED" TOROID IS READ OUT. SWITCH THESE TUBES AROUND AS WELL TO SEE IF YOU TRANSFER THE PROBLEM (IN THIS CASE, SEE IF YOU NOW GET ONLY "LEFT SIDE" PLAY). IT IS EXTREMELY UNLIKELY THAT BOTH TUBES OF EACH SET (2050'S AND 12AX7'S) ARE FAULTY AT THE SAME TIME, SO THAT TUBE TROUBLES CAN USUALLY BE DETECTED BY THIS INTERCHANGE TECHNIQUE.

- A. LEFT SIDE SENSING AMPLIFIER (12 AX7 TUBE)
 - B. RIGHT SIDE SENSING AMPLIFIER (12 AX7 TUBE)
 - C. LEFT SIDE TRIP TUBE (2050)
 - D. RIGHT SIDE TRIP TUBE (2050)
 - E. HIGH VOLTAGE RECTIFIER (6X4 TUBE)
 - F. HIGH VOLTAGE REGULATOR (TWO OA2 TUBES)
 - G. SENSING AMPLIFIER SOCKETS:
SENSING PLUGS INSERT HERE
 - H. MAIN POWER TRANSFORMER
- LEFT AND RIGHT SIDE TUBES (2050's AND 12 AX7s) CAN BE INTERCHANGED FOR CHECKING FAULTY TUBES

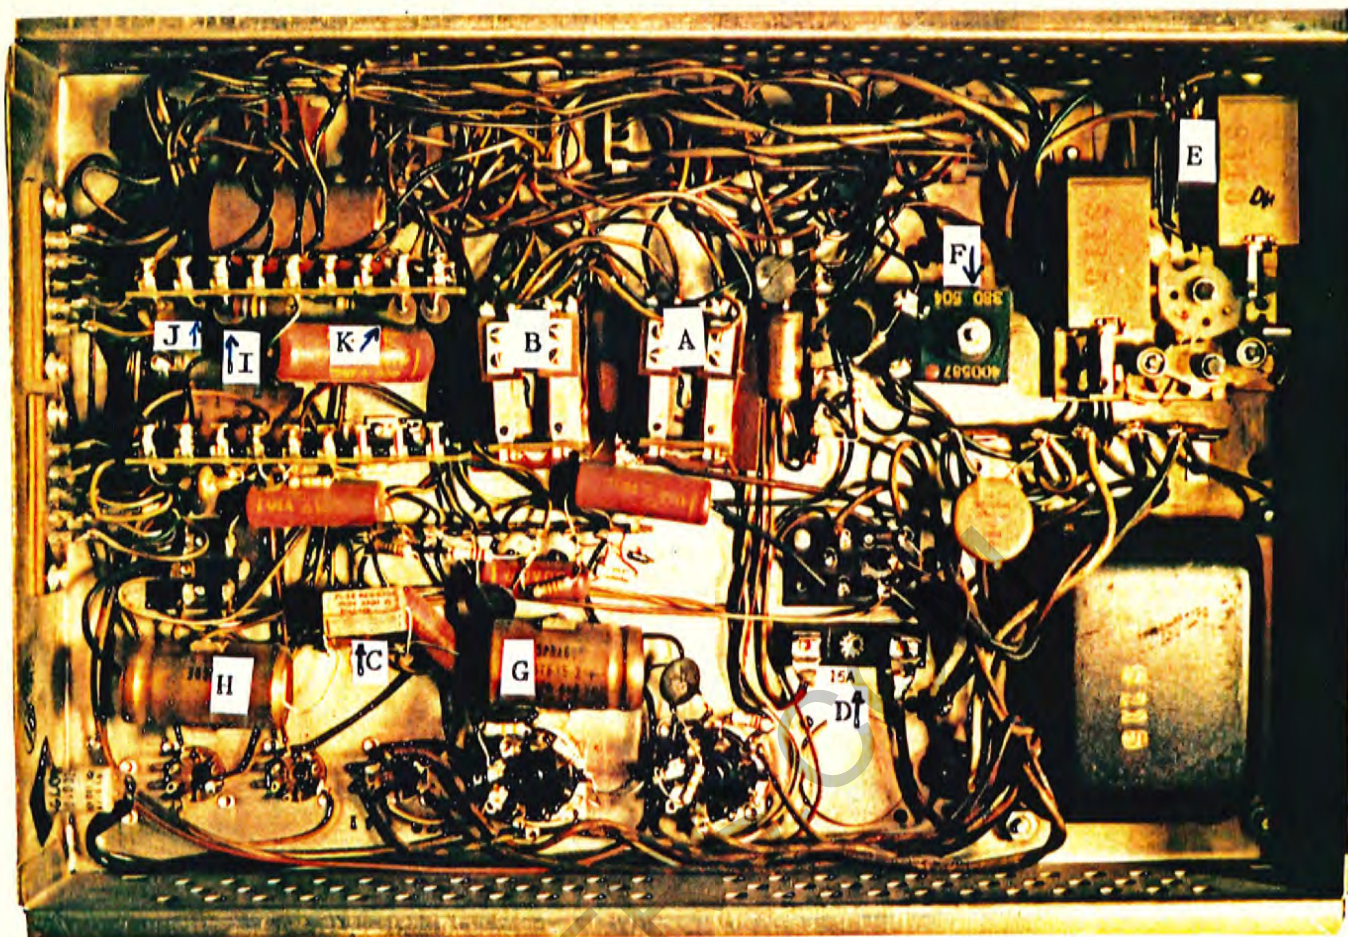
FIG 2 TCC1 ELECTRONICS

4. SHOULD THE ABOVE TESTS NOT ALTER THE TROUBLE SYMPTOMS, OBSERVE THE ACTION OF THE LEFT AND RIGHT SIDE TRIP RELAYS (FIG. 2). AS THE MACHINE REACHES THE SELECTED RECORD, A8 AND B8 IN OUR EXAMPLE, THEY SHOULD BOTH SIMULTANEOUSLY ACTIVATE. THE LEFT SIDE RELAY WILL RELEASE AS SOON AS THE MECHANISM STARTS RECORD TRANSFER (LEFT SIDE). NOTE THAT THE RIGHT SIDE TRIP RELAY MUST STAY ACTIVATED DURING THE ENTIRE DURATION OF LEFT SIDE PLAY, IF BOTH SIDES OF THE SELECTION WERE SELECTED AT THE SAME TIME. IF THE RIGHT SIDE RELAY SHOULD FAIL TO DO SO, YOU CAN TEST IT BY MAKING THE LEFT SIDE SELECTION ONLY (A8 ONLY) AND LETTING THE MACHINE PLAY IT AND THEN MAKING THE RIGHT SIDE SELECTION (B8 ONLY) TO SEE IF IT WILL PLAY THE RIGHT SIDE. IF THIS SEQUENCE WORKS OK (AND IN MOST CASES IT WILL), THE PROBLEM IS VERY LIKELY IN THE HOLDING CONTACTS OF EITHER THE LEFT SIDE RELAY OR THE PLAYING MECHANISM.

- A) CAPACITORS C514 AND C515 HAVE FAILED AT A CONSISTENT RATE. USUALLY THEY SHORT OUT. THIS MEANS THAT THE 6X4 RECTIFIER TUBE WILL USUALLY BE AFFECTED ESPECIALLY IF C514 SHORTS OUT. THE RESULTING CURRENT IS MANY TIMES THE DESIGN RATING OF THIS TUBE AND RESULTS IN INTERNAL SHORTS IN IT. IF C515 SHORTS OUT THE 3300 (3.3K) OHM RESISTOR R518 BURNS OUT. THIS IS A FUSE RESISTOR OF 5W RATING AND SHOWS NO CHANGE IN ITS APPEARANCE WHEN BURNED OUT. THE ONLY WAY TO ASCERTAIN

WHETHER IT IS GOOD OR NOT IS BY USE OF AN OHMMETER.

- B) RESISTORS R519 HAS ALSO OCCASIONALLY BURNED OUT (IT SHOWS VISIBLE DAMAGE). R519 HAS A VALUE OF 2700 OHMS AT A 2W RATING. THE CAUSE MAY BE SHORTED OA2 TUBES (THIS IS RARE).

- C) RESISTORS R514 AND R516 ARE PART OF THE READ-OUT CIRCUITRY AND MAY BE SUBJECT TO CHANGE OF RESISTANCE IF THE MECHANISM IS STATIONARY FOR A LONG TIME WITH THE DETENT SWITCH (R.O.) CLOSED. THIS CAN AGAIN ONLY BE TESTED BY MEANS OF AN OHMMETER. R516 HAS A VALUE OF 36 OHMS, 1/2 WATT AND R514 IS A 56000 OHM RESISTOR OF 2 WATT RATING. THE VALUES FOR ALL THE RESISTORS MENTIONED ABOVE CAN VARY $\pm 10\%$ AND STILL BE GOOD.

- A. LEFT SIDE TRIP RELAY
- B. RIGHT SIDE TRIP RELAY
- C. 3300 OHM FUSE RESISTOR (R518)
- D. CLIP FOR 15 A FUSE (24VAC CIRCUIT)
- E. PLAY CONTROL ASSEMBLY
- F. 40 V BRIDGE RECTIFIER
- G. CAPACITOR C 514
- H. CAPACITOR C 515
- I. R 514 (HIDDEN)
- J. R 516 (HIDDEN)
- K. 2700 OHMS 2W (R 519)

AT THIS TIME, IT WILL BE ADVANTAGEOUS TO CLEAN ALL RELAY AND PLAYING MECHANISM CONTACTS BY MEANS OF A BURNISHING TOOL (PULL THE CONTROL CENTRE 117V PLUG SO THAT NO POWER IS APPLIED). CONTACT PROBLEMS ARE, NEXT TO THE TUBE TROUBLES, THE MOST COMMON CAUSE OF PROBLEMS IN THIS TYPE OF CONTROL CENTRE.

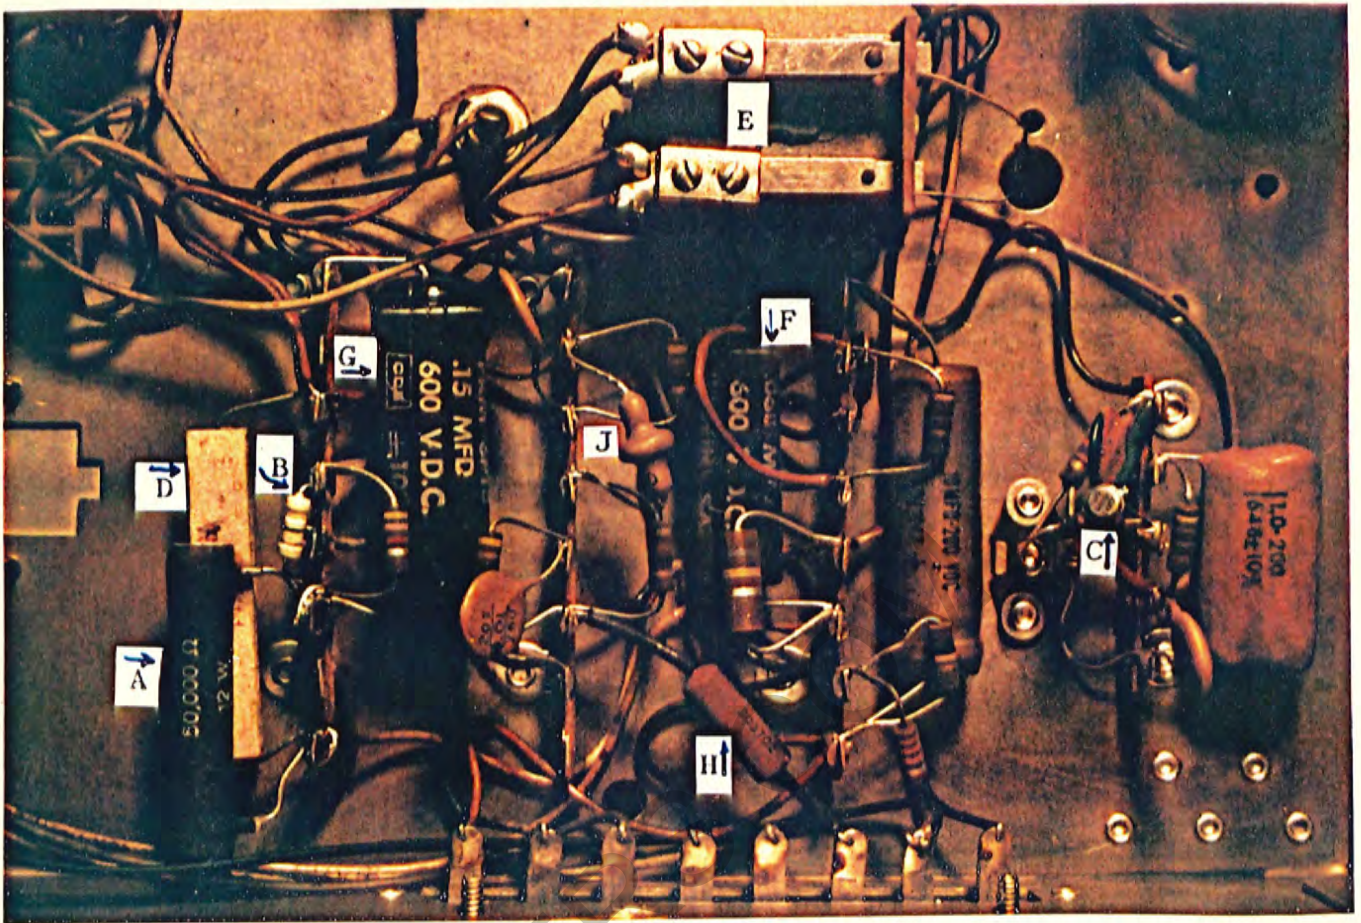
FIG 7 CLOSE-UP OF WRITE-IN/READ-OUT COMPONENTS

(F3102) 1/8 A FUSES THE WRITE-IN AND READ-OUT CIRCUITS (ALSO A TRANSISTOR IN THE STEPPER UNIT OF ALL PLACES!), THIS IS A "PIGTAIL" FUSE SOLDERED INTO PLACE IN MOST OF THESE CONTROL CENTRES. (THIS FUSE APPEARS FIRST IN THE SCC3 AND IS PRESENT THROUGH THE ENTIRE RANGE OF SUBSEQUENT CONTROL CENTRES, INCLUDING ALL "DIGITAL" MODELS. IN PHONOGRAPHS UP TO AND INCLUDING THE LS2, IT BLOWS FOR ONE MAIN REASON: THE FAILURE OF RESISTORS R3107 (56000 OHMS) AND R3109 (36 OHM) SHOWN IN FIG. 6 (IN FIG. 6 AND 7 THEY HAVE BEEN REPLACED BY 50000 AND 39 OHM RESISTORS, RESPECTIVELY. THIS IS BARELY WITHIN THE LIMITS OF DESIGN TOLERANCE). THE REASON FOR FAILURE IS DUE TO A DESIGN PROBLEM AND IS THIS: WHEN THE PLAYING MECHANISM COASTS TO A STOP AFTER HAVING FINISHED WITH THE LAST SELECTION, IT IS EQUALLY POSSIBLE FOR THE DETENT SWITCH (R.O. SWITCH) TO BE IN ITS CLOSED OR OPEN POSITION. IN THE CLOSED POSITION, A CONSTANT CURRENT FLOWS THROUGH BOTH RESISTORS R3107 AND R3109. THIS CURRENT IS LARGE ENOUGH TO CAUSE R3107 TO HEAT UP TO ITS FULL 2 WATT RATING. IN TIME, THIS CAUSES A CHANGE (DOWNWARD) IN ITS INTERNAL RESISTANCE, INCREASING THE CURRENT EVEN MORE. MORE HEAT IS DISSIPATED STILL, RESISTANCE DECREASES SOME MORE, ETC. EVENTUALLY R3109 OVERHEATS TOO. THE CURRENT INCREASES FROM ABOUT 7 MILLIAMPS TO WELL IN EXCESS OF THE 125 MILLIAMPS OF FUSE F3102, WHICH MUST OBVIOUSLY BLOW. FOR ALL THIS THE OUTWARD APPEARANCE OF R3107

HARDLY CHANGES (IT MAY LOOK A LITTLE "PUFFED UP"), BUT IT'S READING WILL SHOW A RESISTANCE OF ONLY A FEW HUNDRED OHMS. THE FUSE WILL HAVE BLOWN SEVERAL TIMES DURING THE TIME IT TAKES FOR ALL THIS TO HAPPEN. SINCE THERE IS NO "OBVIOUS" CAUSE FOR THE FUSE FAILURE, PEOPLE HAVE A TENDENCY TO REPLACE IT WITH A HIGHER RATED ONE (I HAVE SEEN 15A FUSES USED). THIS ACCELERATES THE "AGEING" PROCESS OF THE ABOVE RESISTORS AND DOES NOT CURE ANYTHING; IT WILL HOWEVER RESULT IN THE SHORTING OF THE RECTIFIER DIODES AND/OR BURN-OUT OF THE MAIN POWER TRANSFORMER. THE REAL CURE IS TO REPLACE RESISTOR R3107 WITH ONE THAT IS RATED AT 56000 OHMS, 5 WATTS OR HIGHER. (THE 50000 OHM, 12 WATT RESISTOR IN FIG. 7 IS A BARELY ACCEPTABLE SUBSTITUTE). R3109 (36OHM 1/2 WATT) CAN BE REPLACED WITH EITHER A 39 OHM OR 33 OHM RESISTOR (EACH 1/2 WATT). CHECK RESISTOR R3107 WITH AN OHMMETER IF YOU FIND THE FUSE (F3102) BLOWN.

- C) AN OBSCURE AND VERY SELDOM OCCURRING PROBLEM IS THE OPENING OF INDUCTORS (CHOKES) L3101 AND L3100 WHICH ARE INVOLVED IN SHAPING

THE "WRITE-IN" PULSE. AGAIN, NO VISIBLE DAMAGE IS APPARENT (UNLESS IT IS PHYSICAL DAMAGE). A GOOD INDUCTOR SHOULD SHOW A READING OF APPROXIMATELY 3 OHMS. IN A PINCH, IF NO REPLACEMENT IS AVAILABLE, JUMPERING A SHORT WIRE ACROSS THESE CHOKES FROM ONE END OF THE CHOKE TO THE OTHER, NOT TO CHASSIS GROUND, WILL PUT THE MACHINE BACK INTO OPERATION. BE CAUTIONED THOUGH THAT SHORTING OF COMPONENTS IS NORMALLY A DANGEROUS PRACTICE; IT WORKS HERE ONLY BECAUSE OF THE WAY THE CIRCUIT IS ARRANGED.

- A. NOTICE 50000 OHM, 12W REPLACEMENT FOR R 3107. THIS IS AT THE LOWER LIMIT OF DESIGN TOLERANCE, BUT WORKS OK.
- B. 39 OHM REPLACEMENT FOR R 3109
- C. SILICON CONTROLLED SWITCH (SCS 3100) WHICH ACTIVATES THE TRIP RELAY (E)
- D. R 3106, RESISTOR 7500 OHMS, 10W
- E. TRIP RELAY
- F. WRITE-IN CAPACITOR: THIS STORES THE ENERGY NECESSARY TO PUT A TOROID IN THE TORMAT ASSEMBLY INTO ITS "SELECTED" STATE (TORMAT IS NOT PART OF THE CONTROL CENTRE)
- G. READ-OUT CAPACITOR: STORES ENERGY FOR PUTTING A TOROID INTO ITS "UNSELECTED" STATE.
- H. CHOKE, L 3101
- J. CHOKE, L 3100

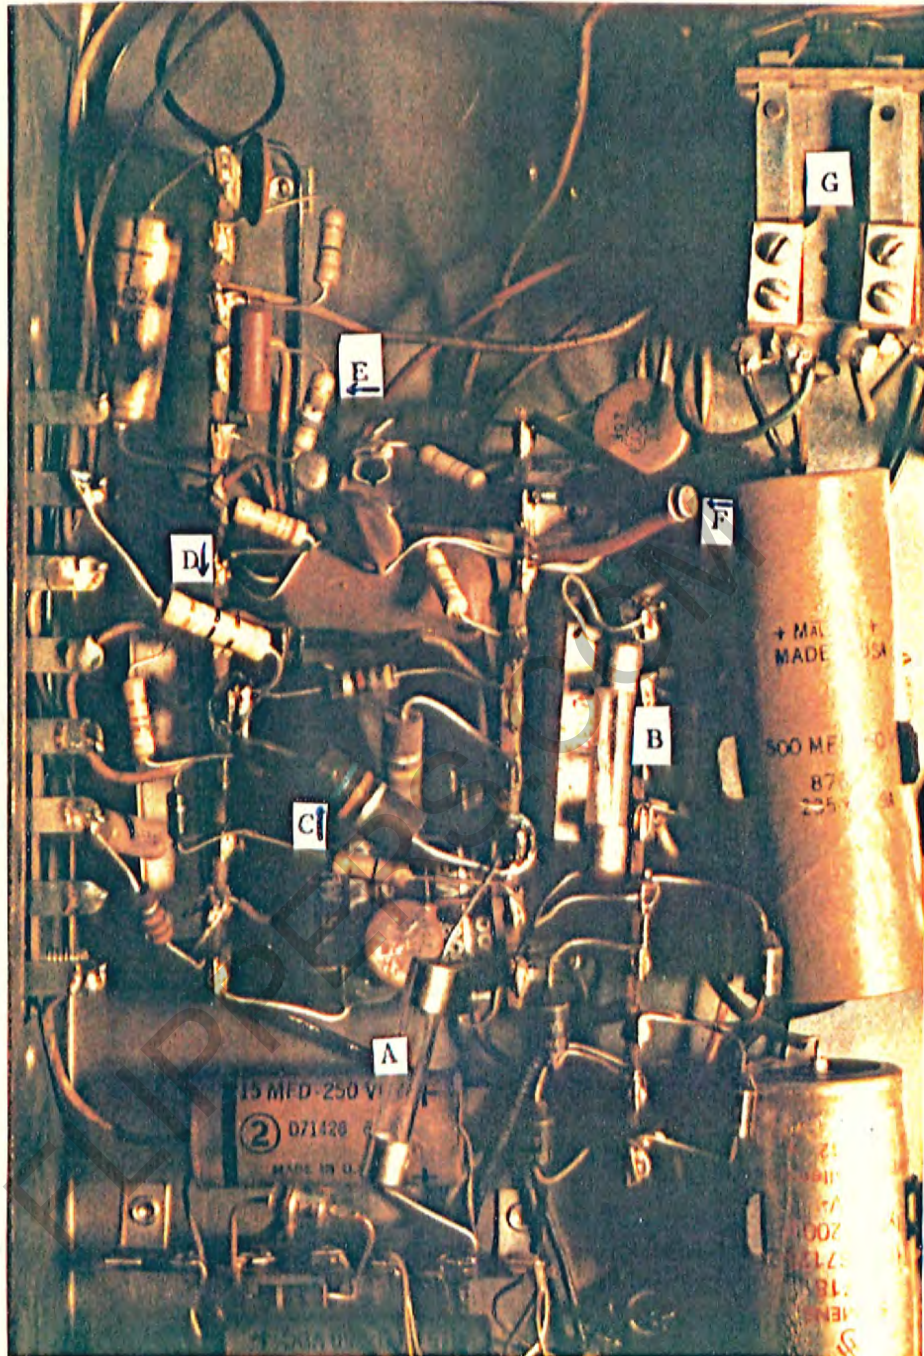
FIG 10 CLOSE UP OF WRITE-IN/READ-OUT SECTION, SCC7 CONTROL CENTRE

- A. 1/8 A FUSE
- B. 1 $\frac{1}{2}$ A FUSE
- C. 56000 OHM RESISTOR, 2W (ORIGINAL EQUIPMENT PART. THIS ONE FAILS OFTEN. REPLACE WITH HIGHER WATTAGE RATING)
- D. 39 OHM, 1W (REPLACEMENT FOR 36 OHM RESISTOR)
- E. NOTICE BURNED OUT RESISTOR, R 3114, 47 OHM, $\frac{1}{2}$ W. PROBABLY CAUSED BY ACCIDENTALLY SHORTING TEST POINT 1 ON TEST TERMINAL TO CHASSIS.
- F. SCS
- G. TRIP RELAY

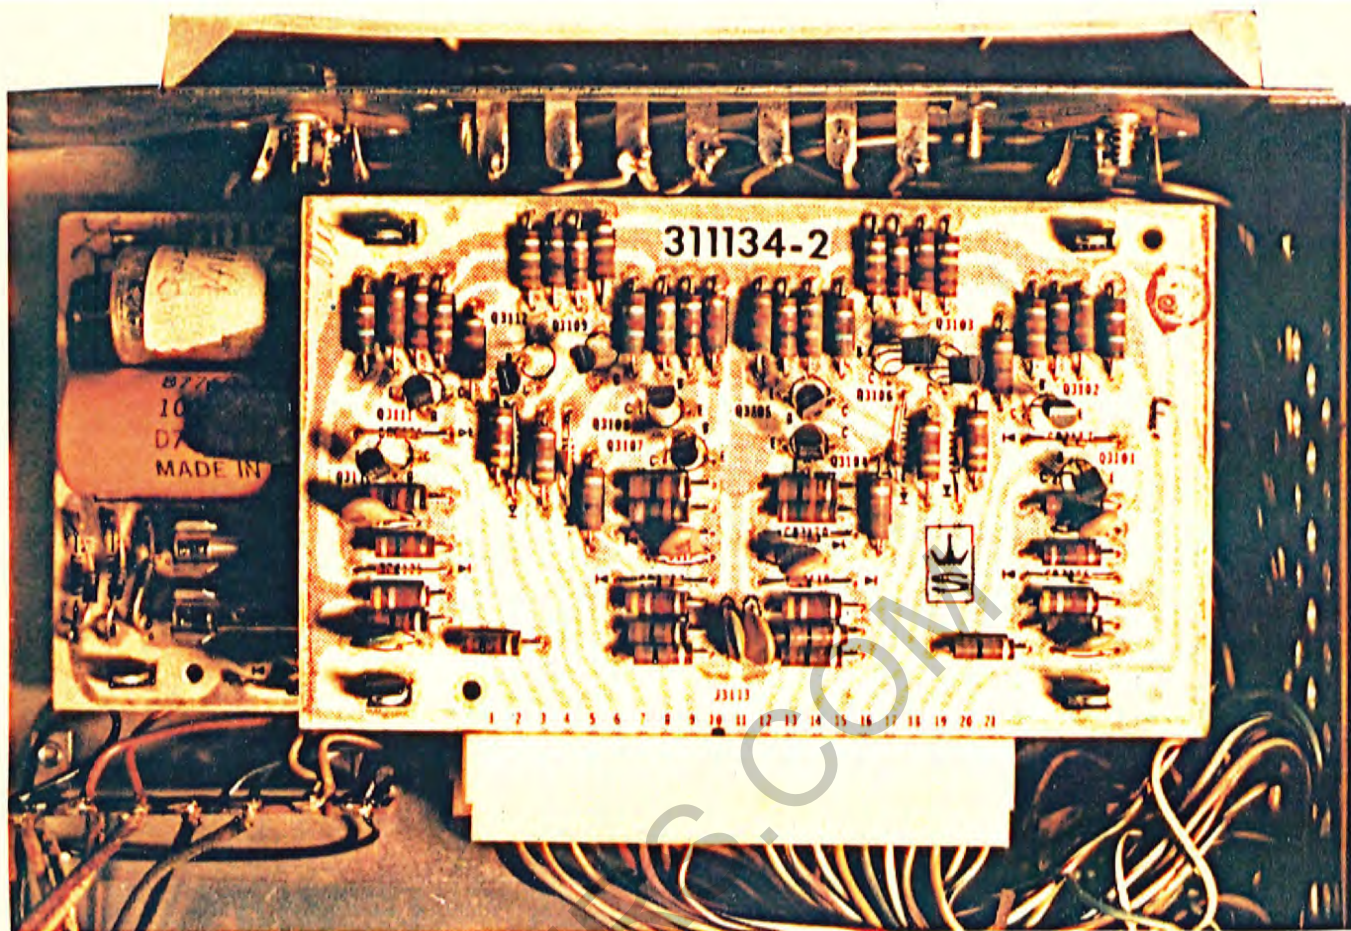
FIG 15 CLOSE-UP OF BUFFER BOARD

THE NEXT AREA OF CONCERN IS THE BUFFER BOARD (FIG. 15). THIS BOARD CONTAINS TWELVE TRANSISTORS WHICH IN ONE WAY OR ANOTHER ARE INVOLVED WITH THE SELECTION INFORMATION TRANSMITTED BY THE BLACK BOX AND THE COIN SWITCH CIRCUITS IN THE PHONOGRAPH. IF ANY PROBLEMS EXIST IN THIS AREA AT ALL, THEY USUALLY INVOLVE EITHER THE TRANSISTORS OR THE CIRCUIT BOARD CONNECTING PLUG. THE TRANSISTORS ARE SUSCEPTIBLE TO MECHANICAL DISTURBANCES SUCH AS LEADS SHORTED TOGETHER DUE TO EXCESSIVE BENDING (THIS CAN CAUSE TRANSISTOR FAILURE). UNFORTUNATELY, THE PHYSICAL LAYOUT OF THIS CONTROL CENTRE MAKES IT VERY EASY TO BEND THE TRANSISTORS OUT OF PLACE. USUALLY "STRAIGHTENING" THE TRANSISTOR RESULTS IN A CURE OF PROBLEMS. NORMALLY, FAULTS SUCH AS MISSING THE SAME SELECTIONS ALL THE TIME OR NO CREDIT FOR A PARTICULAR DENOMINATION COIN (SAY DIMES) ARE ATTRIBUTABLE TO THE BUFFER BOARD.

ANOTHER FUNCTION OF THE BUFFER BOARD IS THE ISOLATION OF WALL BOXES (REMOTE SELECTORS, IE. STEREO CONSOLETTES) FROM THE BLACK AND GREY BOXES IN THE PHONOGRAPH. AS YOU WELL KNOW, PEOPLE WILL TRY ANYTHING, INCLUDING STICKING PINS INTO ACCESSIBLE WALLBOX WIRING IN ORDER TO GET FREE PLAYS. THE BUFFER BOARD SEES TO IT THAT SUCH OCCURENCES DO NOT DAMAGE THE ELECTRONICS IN THE PHONOGRAPH AND THAT THE PHONOGRAPH, AT LEAST, IS STILL OPERATIONAL. OCCASIONALLY, CERTAIN FAULTS IN THIS BUFFER BOARD MAY THEREFORE AFFECT WALLBOX OPERATION, BUT LEAVE THE PHONOGRAPH ITSELF WORKING PROPERLY. ON THE WHOLE, BUFFER BOARD PROBLEMS DO NOT OCCUR TOO OFTEN. CHECK THE CONNECTING PLUG PINS FOR GOOD CONNECTION AND MECHANICAL ALIGNMENT (REFER TO H.B.V.'S AMPLIFIER MANUAL). THE PROPER OPERATION OF THIS BUFFER BOARD IS DEPENDENT ON THE -27 VOLT CIRCUIT AND +8.2 VOLTS DERIVED FROM THE +27 VOLT CIRCUIT WHICH ARE GENERATED ON THE POWER SUPPLY BOARD (SEE ABOVE).

MAKE SURE TRANSISTORS ARE NOT "SQUASHED DOWN", BUT APPEAR AS SHOWN HERE.

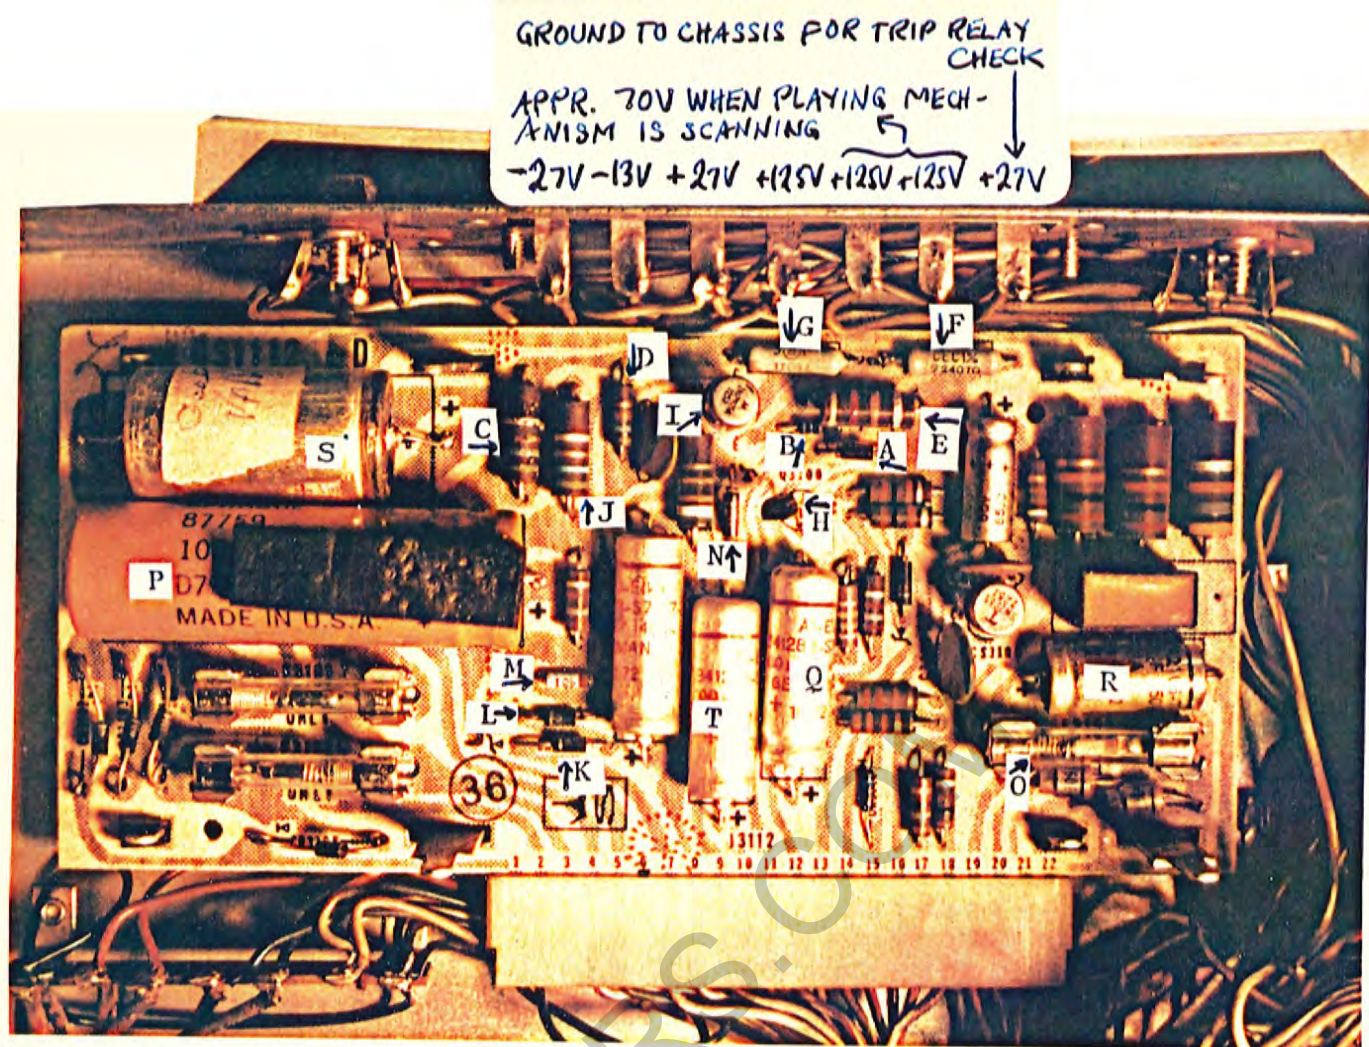
FIG 16 CLOSE-UP OF POWER SUPPLY BOARD. REFER TO TEXT FOR COMPONENT VALUES.

AMP FUSE. ONE OF THE 8/10 AMP FUSES (FIG. 13A, 16) PROTECTS THE +27 VOLT SUPPLY, THE OTHER PROTECTS THE -27 VOLT SUPPLY. THE 1/8A FUSE PROTECTS THE WRITE-IN READ-OUT SUPPLY. IN ADDITION, THERE IS THE 15A FUSE LOCATED RIGHT NEXT TO THE MAIN POWER TRANSFORMER WHICH PROTECTS THE 25 VOLT AC CIRCUIT (PLAY CONTROL AND TRIP SOLENOIDS). ON SOME CONTROL CENTRES THERE EXISTS AN ADDITIONAL RED HEADED FUSE OF 3.2A RATING, LOCATED ON THE "OUTSIDE" OF THE CONTROL CENTRE NEAR THE MAIN POWER TRANSFORMER. THIS FUSE IS MEANT FOR A DOLLAR BILL VALIDATOR (ONLY IN U.S. MODELS) AND IS NON-FUNCTIONAL IN ALL OUR MACHINES. THIS FUSE IS A HANDY "SPARE" FOR THOSE MACHINES EQUIPPED WITH AN SHP TYPE AUDIO AMPLIFIER WHICH HAS AN IDENTICAL FUSE. ON LATER MODELS THE FUSEHOLDER WAS EMPTY AND "CAPPED". THE FAILURE OF FUSE F3102 (-27V) RESULTS IN LOSS OF POWER FOR THE BLACK AND GREY BOXES AND WHAT WOULD OBVIOUSLY BE A CREDIT PROBLEM (I.E. THE BLACK BOX IS RESPONSIBLE FOR CREDIT FUNCTIONS, AMONG OTHER THINGS). THE MAIN REASON FOR BLOWING THIS FUSE IS FOUND TO BE A FAULTY PREREGULATOR CIRCUIT (AN EVEN MORE COMMON CAUSE IS A FAULTY BLACK OR GREY BOX, OBVIOUSLY NOT A CONTROL CENTRE PROBLEM). THE COMPONENTS TO CHECK HERE ARE TRANSISTOR Q3120, RESISTORS R3111, R3112, R3113 AND DIODES CR3112 AND CR3110. THIS DIODE (CR3110) IS THE -13 VOLT ZENER REGULATOR DIODE WHICH IS IMPORTANT FOR THE OPERATION OF BOTH BLACK AND GREY BOXES. INSPECT THE RESISTORS FOR ANY EVIDENCE OF OVERHEATING (REFER TO FIG. 16). TRANSISTOR Q3120 CAN BE CHECKED AS POINTED OUT IN HUDSON'S BAY VENDING MANUAL ON SEEBURG AMPLIFIERS. RESISTORS R3189 AND R3190 ARE CLOSE TOLERANCE (1%) WIRE WOUND RESISTORS WHICH WILL SHOW A DEFINITE "BROWNING" EFFECT WHEN SOMETHING HAS GONE WRONG WITH SOME OF THE OTHER ABOVE MENTIONED COMPONENTS. CHECK THEM WITH AN OHMMETER. THEY DO NOT NORMALLY BURN OUT. IN ADDITION, THE RESET CIRCUIT, OF WHICH TRANSISTOR Q3100 (FIG. 16) IS THE MAIN COMPONENT, CAN FAIL CAUSING THE PHONOGRAPH TO GIVE FREE CREDITS WHENEVER THE MAIN POWER SWITCH IS TURNED ON. THE MOST COMMON BREAKDOWNS IN THE ABOVE MENTIONED COMPONENTS ARE TRANSISTOR Q3120, R3113, R3111, TRANSISTOR Q3100, R3113 WHEN BURNED INDICATES THAT Q3120 IS TO BE REPLACED.

INSPECT ALL ELECTROLYTIC FILTER CAPACITORS ON THIS BOARD FOR LEAKAGE OR POOR SOLDER CONNECTIONS. SHORTED FILTER CAPACITORS CAN CAUSE ANY OF THE POWER SUPPLY BOARD FUSES TO BLOW. THESE CAPACITORS ARE: C3109, C3107, C3105, AND C3106. POOR SOLDER CONNECTIONS CAN CAUSE AN UNPREDICTABLE PHONOGRAPH BEHAVIOR, SUCH AS SUBTRACTING TOO MANY CREDITS , OR WRONG SELECTIONS AMONG OTHERS.

- A. CR 3110
- B. CR 3112
- C. R 3111 -THIS ONE LOOKS LIKE IT HAS BEEN SUBJECT TO OVERHEATING
- D. R 3112
- E. R 3113
- F. R 3189
- G. R 3190
- H. Q 3100
- I. Q 3120
- J. R 3108
- K. CR 3104
- L. CR 3105
- M. CR 3106
- N. CR 3107
- O. 1/8 A FUSE, WI/RO SUPPLY
- P. C 3109
- Q. C 3107
- R. C 3100
- S. C 3105
- T. C 3106

CR 3110	-13V Zener Diode Part #309613	
R 3111	5.6 OHMS	2W
R 3112	560 OHMS	1/2W
R 3113	THIS CAN BE REPLACED 390 OHMS	1/2W
R 3189	BY ANY VALUE UP TO 634 OHMS (1%)	1/2W
	820 OHM, 1 W	
R 3190	750 OHMS (1%)	1/2W
Q3100 Transistor	#309684) SEEBURG PARTS NUMBERS
Q3120 Transistor	309685

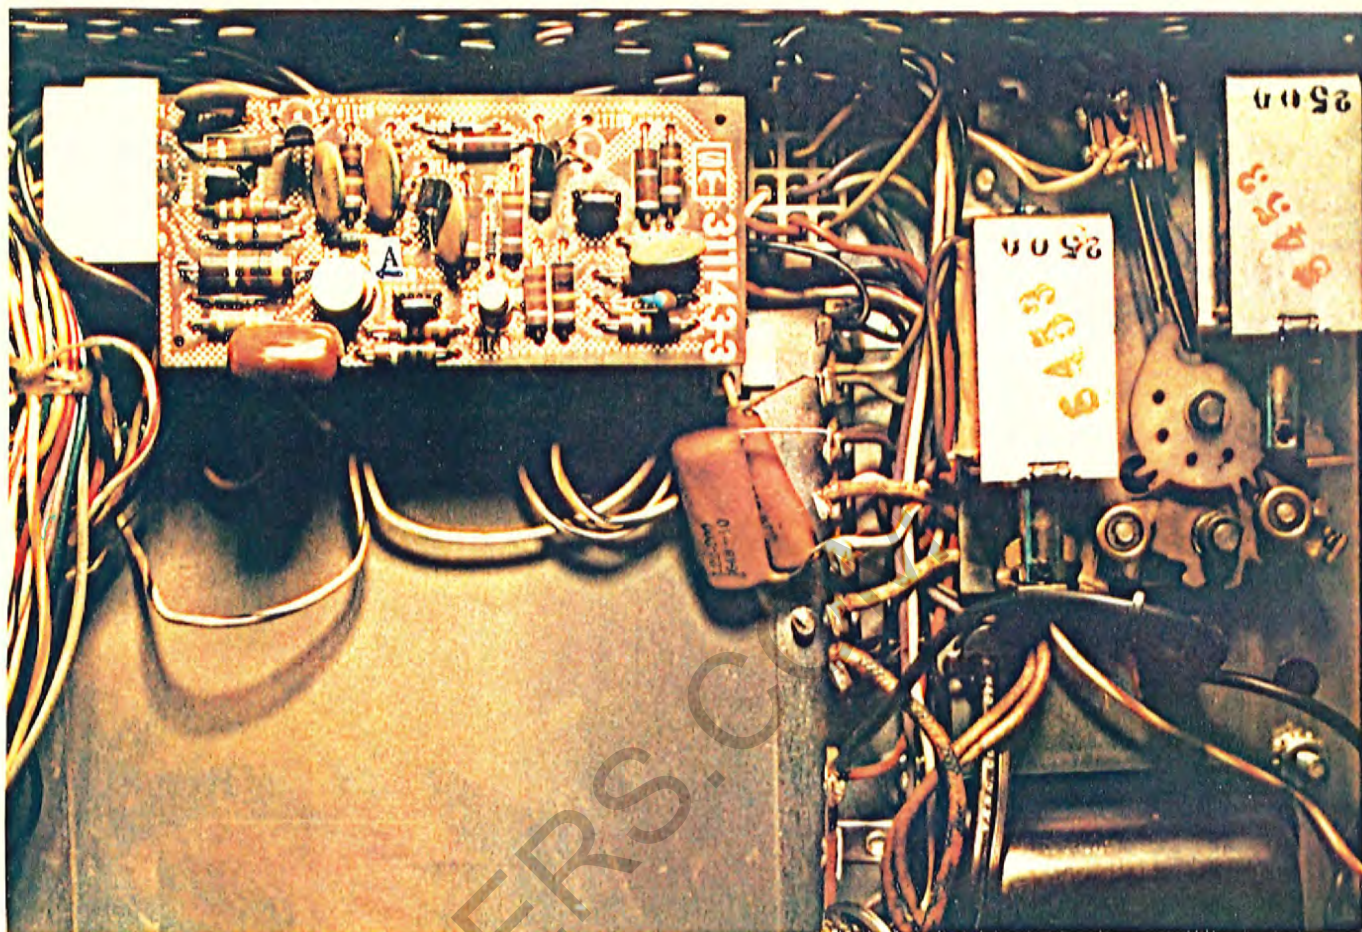
FIG 17 SCAN BOARD

THE LAST MAJOR ELECTRONIC SUBASSEMBLY IS THE "SCAN BOARD". FOR A BOARD WHICH HAS REALLY ONLY ONE FUNCTION (THE AMPLIFICATION OF THE SCAN SIGNAL FROM THE GREY BOX SO THAT IT CAN BE USED TO OPERATE THE PLAY CONTROL "ADD" SOLENOID AND THE TOTAL PLAY COUNTER), IT IS SURPRISINGLY COMPLEX (REFER TO FIG. 17). THERE IS NO DOUBT THAT NOWADAYS IT WOULD BE REPLACED BY A SINGLE INTEGRATED CIRCUIT TUCKED AWAY IN SOME CORNER OF THE POWER SUPPLY BOARD. THE SCAN BOARD IS JUST AS "EXPOSED" AS THE BUFFER BOARD AND THE MOST COMMON PROBLEM IS THAT THE TRIAC, Q3115, IS BENT AGAINST THE SCAN BOARD MOUNTING POST CAUSING THE PLAY CONTROL ADD SOLENOID TO BE ACTIVATED ALL THE TIME SO THAT THE PHONOGRAPH PLAYING MECHANISM SCANS CONTINUOUSLY (SELECTIONS MADE WILL BE PICKED UP. A FAULTY SUBTRACT SWITCH MENTIONED ABOVE COULD ALSO CAUSE THIS CONDITION). ON THE OTHER HAND, A FAULT IN ONE OF THE OTHER COMPONENTS COMPRISING THE SCAN BOARD CAN RESULT IN THE SCAN SIGNAL FROM THE GREY BOX NOT BEING PASSED ALONG TO THE PLAY CONTROL ASSEMBLY. THE PHONOGRAPH WILL NOT START A SCAN (AND THEREFORE WILL NOT PLAY A RECORD) WHEN A SELECTION IS BEING MADE BY A CUSTOMER. WHEN THE SERVICE TECHNICIAN ARRIVES ON LOCATION AND OPERATES "MANUAL SCAN START", ON THE SERVICE SWITCH ASSEMBLY IN THE PHONOGRAPH, ALL PREVIOUSLY SELECTED RECORDS WILL BE PICKED UP. USUALLY THE FAULT IS IN ONE OF THE

TRANSISTORS (OPEN OR SHORTED); OCCASIONALLY THE TRIAC Q3115 IS FAULTY ITSELF AND MUST BE REPLACED. IN THE ABSENCE OF THE PROPER DIAGNOSTIC TOOL (AN OSCILLOSCOPE), THIS IS A TRIAL AND ERROR PROCEDURE, IE. TRY ANOTHER TRIAC. LET IT BE SAID HERE THAT SCAN BOARD PROBLEMS ARE NOT TOO NUMEROUS, OR COMMON.

A. Q 3115 TRIAC
