SEEBURG PHONOGRAPH
CONTROL CENTRES

GENERAL INFORMATION

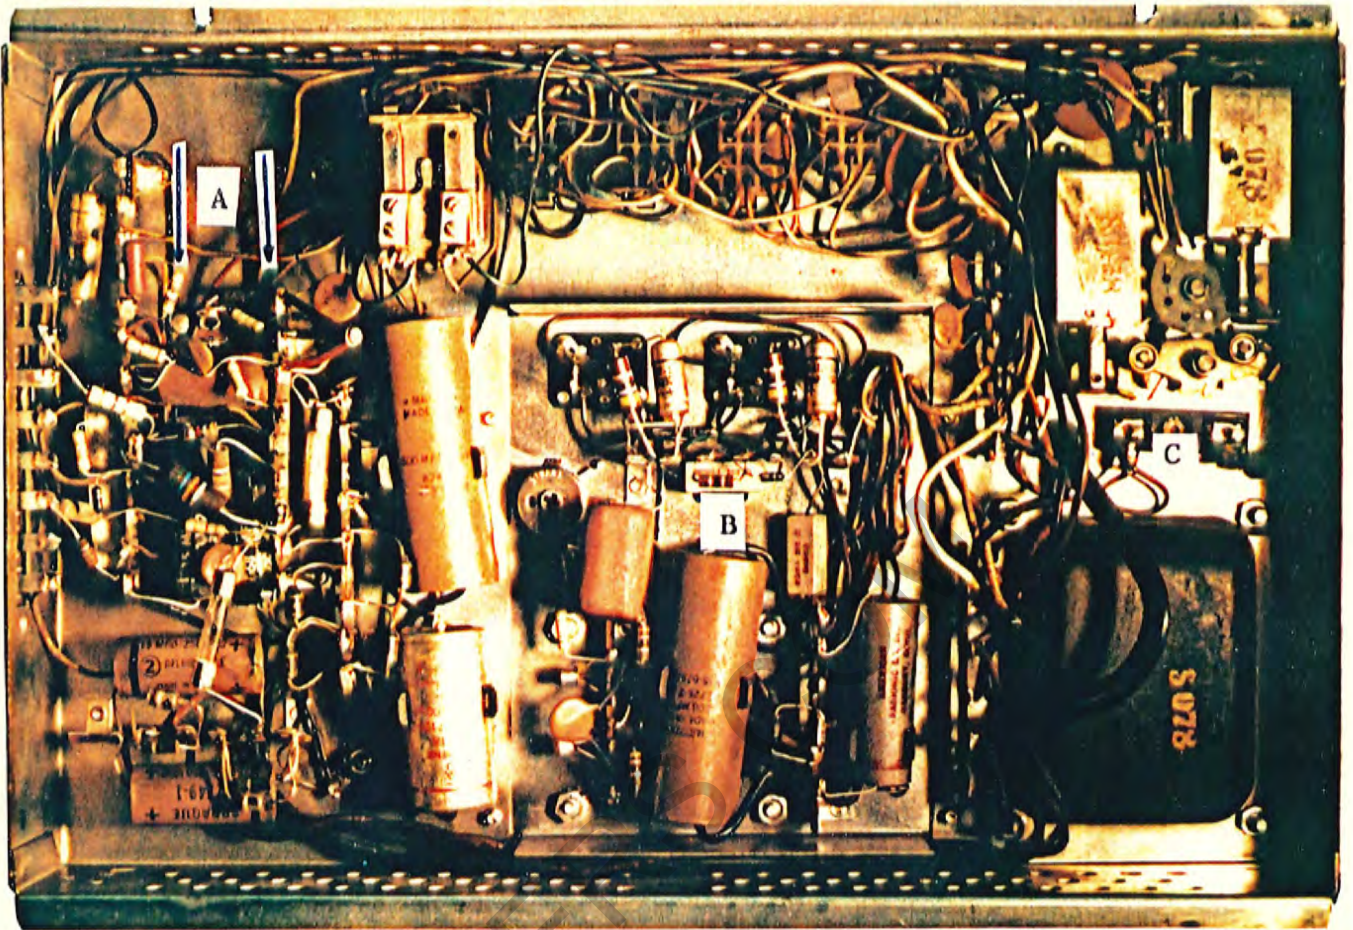
FIG 8 SCC7 CONTROL CENTRE

NOTICE THE "AUTO SPEED" UNIT IS NOW INTEGRATED INTO THE CONTROL CENTRE.

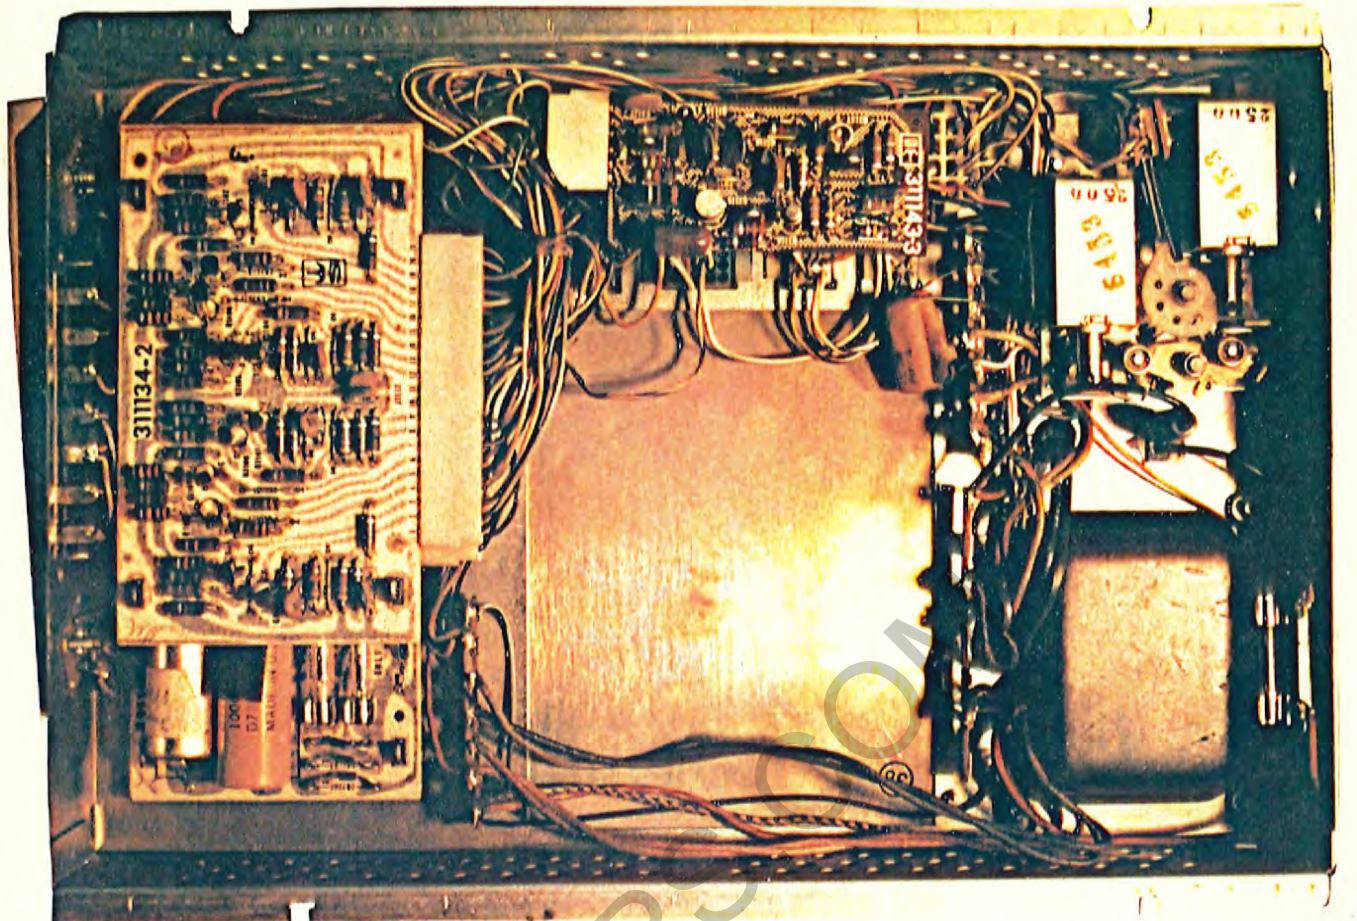
FIG 12 DCC 4 DIGITAL CONTROL CENTRE
THIS UNIT IS REPRESENTATIVE OF ALL DIGITAL CONTROL CENTRES.

THIS ALLOWS THE MECHANISM TO PICK UP SELECTIONS AS IT GETS TO THEM; SIMPLIFIES MATTERS APPRECIABLY AND IS THE SYSTEM WITH WHICH ALL PHONOGRAPHS HAVE BEEN WORKING SINCE. THE USE OF THE 45RPM AUTOSPEED FOR 45RPM RECORDS CONTINUED UNTIL THE END OF 1966. STARTING IN 1967, SEEBURG WENT BACK TO CONSIDER 45RPM RECORDS AS THE STANDARD, ELIMINATING THE NEED FOR AN AUTOSPEED FOR THESE RECORDS. HOWEVER, NOW 33-1/3RPM RECORDS NEEDED AN "AUTOSPEED". THIS WAS INCORPORATED AS A SUBASSEMBLY INTO THE CONTROL CENTRE (UP TO NOW, THE AUTOSPEED UNITS HAD BEEN MOUNTED ON A SEPARATE CHASSES), BUT HAD NO DIRECT INFLUENCE ON THE CONTROL CENTRE ELECTRONICS. THIS AUTOSPEED HAS BEEN USED EVER SINCE, EXCEPT THAT IT LATELY HAS BECOME AN OPTION (SEE FIG. 12 WHERE IT IS MISSING AND REPLACED BY A DUMMY PLUG).

THE CONTROL CENTRE IS EQUIPPED WITH A TERMINAL BOARD WHICH ALLOWS FOR THE TESTING OF THE IMPORTANT VOLTAGES GENERATED BY THE POWER SUPPLY BOARD (SEE FIG. 12). IT IS IMPERATIVE THAT THE VOLTAGES DEVIATE NO MORE THAN 3% FROM THE VALUES MARKED ON THE CHASSIS. FOR THIS REASON, ANY CONTROL CENTRE MUST BE CHECKED BY READING THESE VOLTAGES WITH A VOLTMETER. REFER TO FIG. 16 FOR THE VOLTAGES TO BE READ IN THIS MANNER. VOLTAGES WHICH DEVIATE FROM THE NORM BY MORE THAN THE ABOVE MARGIN INDICATE TROUBLE WHICH EXISTS ON THE POWER BOARD AND/OR BLACK OR GREY BOXES (IF THE CONTROL CENTRE IS HOOKED INTO A PHONOGRAPH). THE FUNCTIONS OF THE CONTROL CENTRE ARE SHOWN IN FIGURE 18 AS PART OF THE ENTIRE PHONOGRAPH CYCLE. THE ONLY UNIT NOT DEPENDENT ON THE CONTROL CENTRE IS THE AMPLIFIER. IT HAS ITS OWN INTERNAL POWER SUPPLY.

- A. NOTICE AUTO SPEED MISSING,
- B. AUTO SPEED DUMMY PLUG
- C. TEST POINT TERMINALS PLASTIC COVER
- D. TORMAT SENSING PLUG FITS HERE

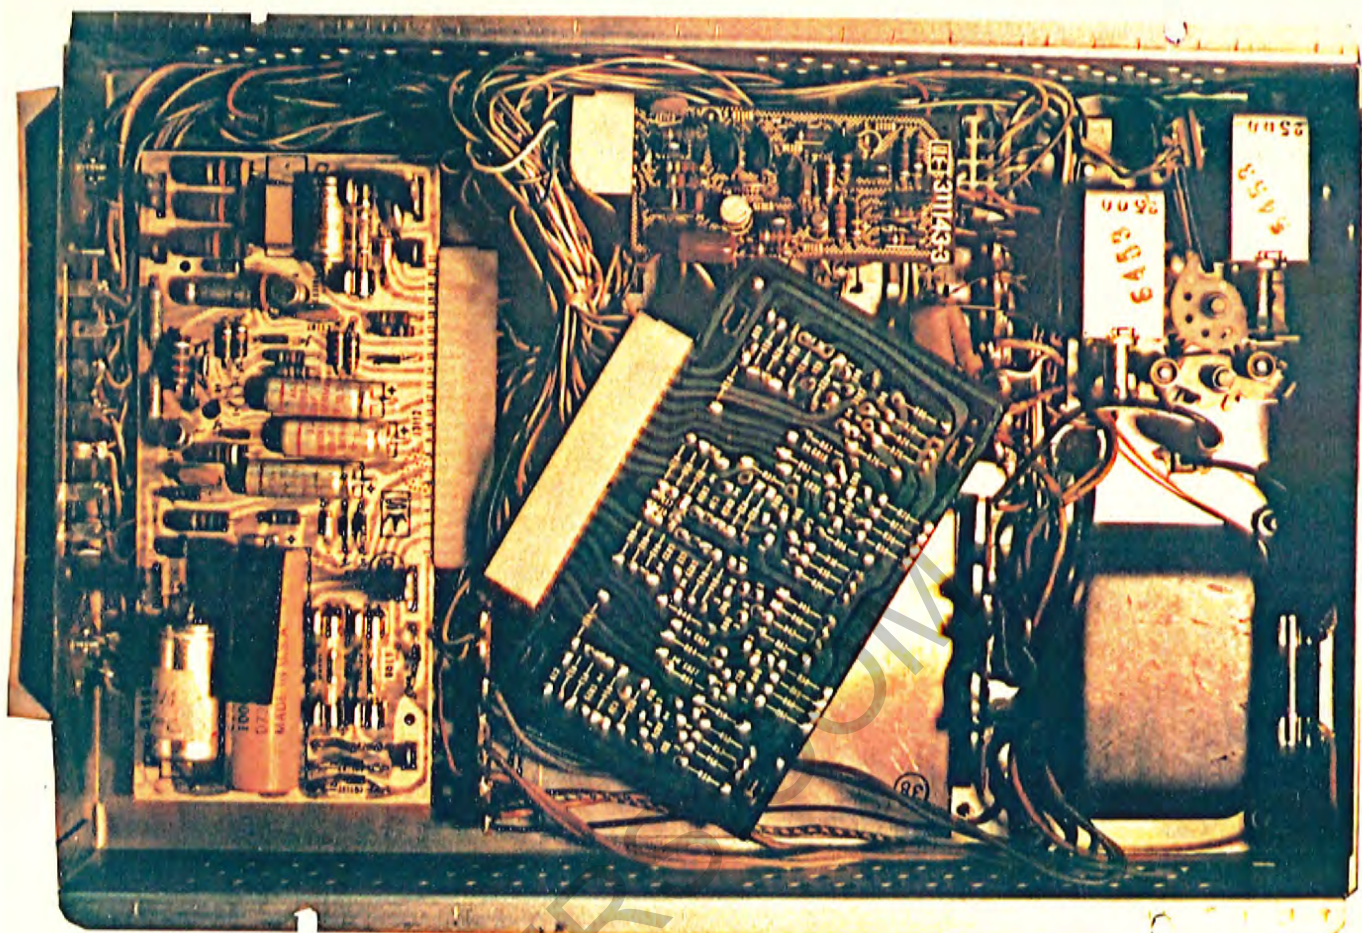
FIG 13A (FUSES F 3101 AND F 3102 VARY FROM 6/10 TO 1 AMP OVER THE VARIOUS DIGITAL CONTROL CENTRES)

AMP FUSE. ONE OF THE 8/10 AMP FUSES (FIG. 13A, 16) PROTECTS THE +27 VOLT SUPPLY, THE OTHER PROTECTS THE -27 VOLT SUPPLY. THE 1/8A FUSE PROTECTS THE WRITE-IN READ-OUT SUPPLY. IN ADDITION, THERE IS THE 15A FUSE LOCATED RIGHT NEXT TO THE MAIN POWER TRANSFORMER WHICH PROTECTS THE 25 VOLT AC CIRCUIT (PLAY CONTROL AND TRIP SOLENOIDS). ON SOME CONTROL CENTRES THERE EXISTS AN ADDITIONAL RED HEADED FUSE OF 3.2A RATING, LOCATED ON THE "OUTSIDE" OF THE CONTROL CENTRE NEAR THE MAIN POWER TRANSFORMER. THIS FUSE IS MEANT FOR A DOLLAR BILL VALIDATOR (ONLY IN U.S. MODELS) AND IS NON-FUNCTIONAL IN ALL OUR MACHINES. THIS FUSE IS A HANDY "SPARE" FOR THOSE MACHINES EQUIPPED WITH AN SHP TYPE AUDIO AMPLIFIER WHICH HAS AN IDENTICAL FUSE. ON LATER MODELS THE FUSEHOLDER WAS EMPTY AND "CAPPED". THE FAILURE OF FUSE F3102 (-27V) RESULTS IN LOSS OF POWER FOR THE BLACK AND GREY BOXES AND WHAT WOULD OBVIOUSLY BE A CREDIT PROBLEM (I.E. THE BLACK BOX IS RESPONSIBLE FOR CREDIT FUNCTIONS, AMONG OTHER THINGS). THE MAIN REASON FOR BLOWING THIS FUSE IS FOUND TO BE A FAULTY PREREGULATOR CIRCUIT (AN EVEN MORE COMMON CAUSE IS A FAULTY BLACK OR GREY BOX, OBVIOUSLY NOT A CONTROL CENTRE PROBLEM). THE COMPONENTS TO CHECK HERE ARE TRANSISTOR Q3120, RESISTORS R3111, R3112, R3113 AND DIODES CR3112 AND CR3110. THIS DIODE (CR3110) IS THE -13 VOLT ZENER REGULATOR DIODE WHICH IS IMPORTANT FOR THE OPERATION OF BOTH BLACK AND GREY BOXES. INSPECT THE RESISTORS FOR ANY EVIDENCE OF OVERHEATING (REFER TO FIG. 16). TRANSISTOR Q3120 CAN BE CHECKED AS POINTED OUT IN HUDSON'S BAY VENDING MANUAL ON SEEBURG AMPLIFIERS. RESISTORS R3189 AND R3190 ARE CLOSE TOLERANCE (1%) WIRE WOUND RESISTORS WHICH WILL SHOW A DEFINITE "BROWNING" EFFECT WHEN SOMETHING HAS GONE WRONG WITH SOME OF THE OTHER ABOVE MENTIONED COMPONENTS. CHECK THEM WITH AN OHMMETER. THEY DO NOT NORMALLY BURN OUT. IN ADDITION, THE RESET CIRCUIT, OF WHICH TRANSISTOR Q3100 (FIG. 16) IS THE MAIN COMPONENT, CAN FAIL CAUSING THE PHONOGRAPH TO GIVE FREE CREDITS WHENEVER THE MAIN POWER SWITCH IS TURNED ON. THE MOST COMMON BREAKDOWNS IN THE ABOVE MENTIONED COMPONENTS ARE TRANSISTOR Q3120, R3113, R3111, TRANSISTOR Q3100, R3113 WHEN BURNED INDICATES THAT Q3120 IS TO BE REPLACED.
